Manhole Inspection Summary

Manhole # S33A__001MH

Location Address: **105 MONUMENT ST**

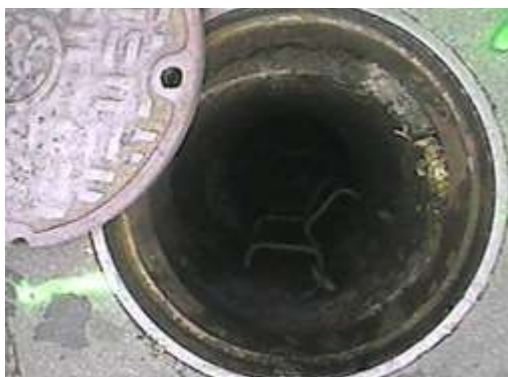
Top View

Offset: **2** (in.)

FRAME OFFSET

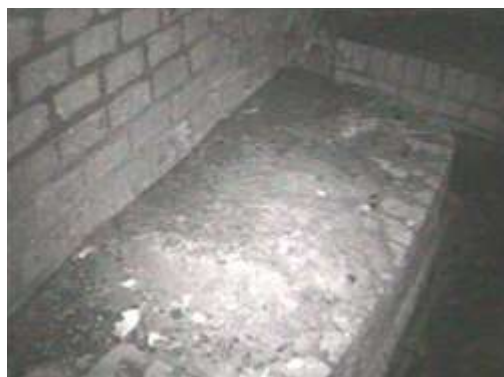
I@9

PIPE DOES NOT EXTEND TO THE
MANHOLE. MUST DIVE TO GET
PICTURE FROM AROUND THE

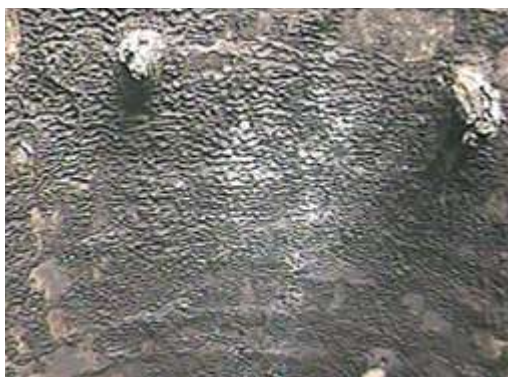
Defect 1

Count: **11** Missing: **1** ☒ **Corroded**

MISSING/ CORRODED RUNG

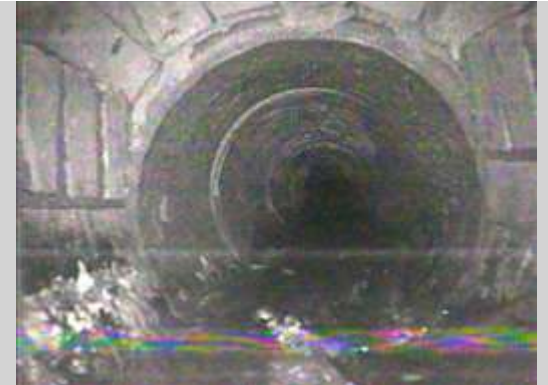
12 O'Clock Outflow

Pipe Height: **15.6** (in.) Rod and Bar (Angled)
Pipe Material: **Clay** ☐ Pipe Lined
Invert Depth: **18.40** (ft.) Flow Characteristics: **Fast**
Deposits: ☒ None ☐ Mud ☐ Sludge ☐ Debris ☐ Grease
Silt Depth: (in.) Deposits Extent:
Infiltration: **None** Pipe Seal Cond: **Sound**

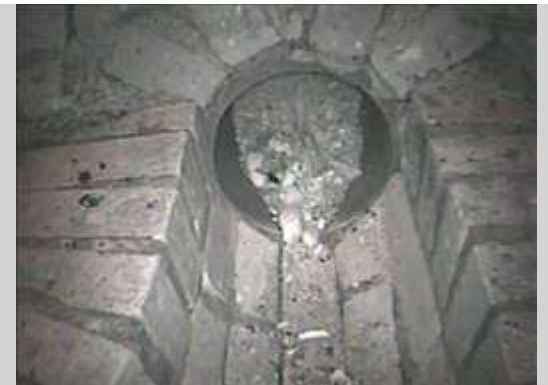
3 O'Clock Inflow

Pipe Height: **8.4** (in.) Rod and Bar (Angled)
Pipe Material: **Clay** ☐ Pipe Lined
Invert Depth: **17.50** (ft.) Flow Characteristics: **None**
Deposits: ☐ None ☐ Mud ☐ Sludge ☒ **Debris** ☐ Grease
Silt Depth: **8** (in.) Deposits Extent: **Heavy**
Infiltration: **None** Pipe Seal Cond: **Sound**

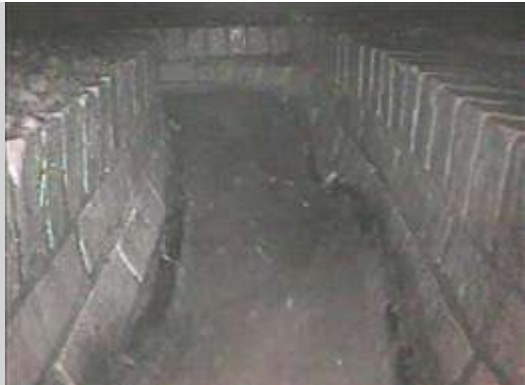
9 O'Clock Inflow

PIPE DOES NOT EXTEND TO THE
MANHOLE. MUST DIVE TO GET PICTURE
FROM AROUND THE CORNER.

Infiltration: **None** Pipe Seal Cond: **Unknown**
